The geopolymer composition for restoration, construction and substitution

Hanzlicek Tomas, Perna Ivana, Steinerova Michaela

The Institute of Rock Structure and Mechanics of the Academy of Sciences in collaboration with Sculpture and restoration school of prof. P.Siegel City of Adršpach,

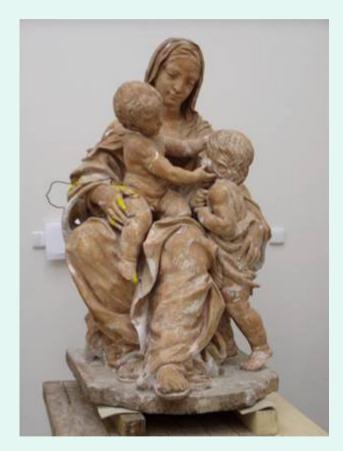
Guiseppe Mario Mazza (1653-1741)

- The front view "Virgin Maria with child Jesus and John Baptist"
- High 1.42 m
- Material terracotta
- Support sandstone

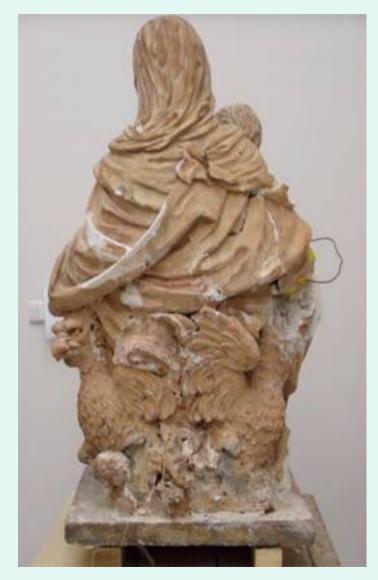
State before restoration

- Rear view with large damages all over the sculpture – visible cracks and fissures missing parts, etc.
- The stabilization previously saturated by calcareous binding agents inside the statue.
 Damage also on robe and its gathering and two eagles in lower rear part were partially destroyed.

- Joint of two original pieces of terracotta by geopolymer composite with calculated amount of non plastic additives.
- Outside coloration repeating the color of terracotta and done by combination of colored clays (content of natural iron oxides in used clays).

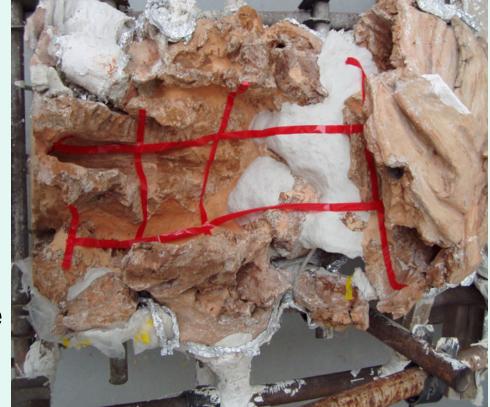
View from the open rear

- All damaged rear parts and all kind of cementitious agents were removed.
- Red strips mark the reinforcement plan of geopolymer ribs.
- The white parts are made from plasticine to avoid the penetration of the geopolymer on the front modulation.

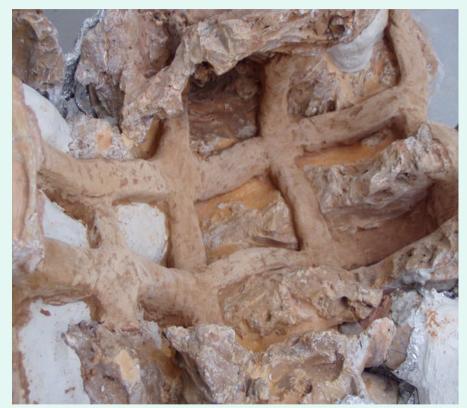
State after the first geopolymer application

- The lengthways and cross ribs fixing the terracotta front parts.
- The specific singularity in masters technology was in picking the terracotta material from the inner part of the statue

irregularity in thickness of the body caused cracks and fissures during the drying and later firing of the statue - the formation of "black core" identifies the irregularity in firing process.
- White parts on the left is the plasticine support of the ribs, this will be finally replaced by ceramic.

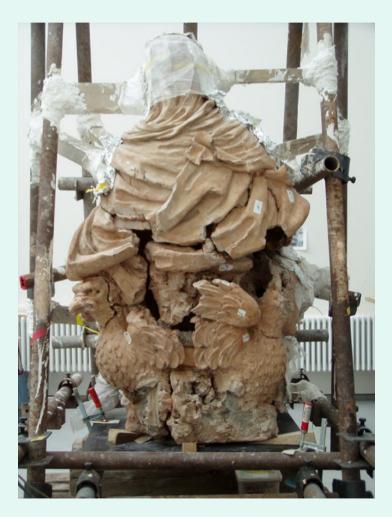
Replacement of rear parts

- Every returned rear part of the statue means extension of the ribs, fixing them on geopolymer reinforcement.
- The main advantage is possibility of perfect joint between previous and new part of inner ribs.
- The picture shows the whole range of damages on the rear side and necessity of reinforcement.

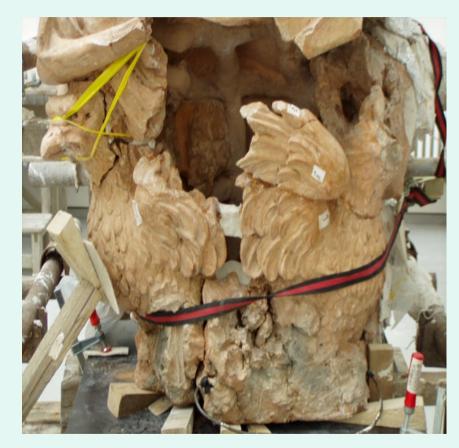
Detailed view – inner ribs

- Each part of terracotta was fixed by new portion of geopolymer rib,
- Between the eagles could be seen white strip of plasticine substituting temporary missing part of out viewed modulation.
- The fixed parts were in many cases temporary secured by plastic bands or ropes and also by wooden spars, etc.

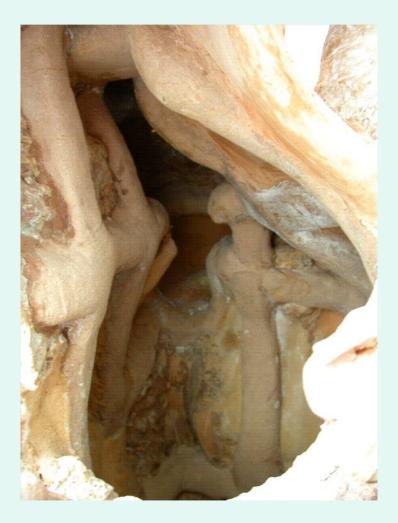
The final stage

- Side view on the reinforcement inner construction before replacement of the last part of right shoulder.
- The lengthways strips are ending in the statue neck supporting the Virgin head.
- Geopolymer construction fully stabilized the statue and any filling material was not necessary.

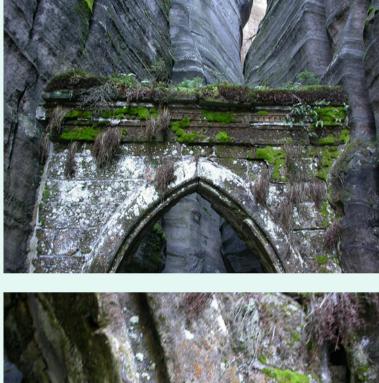
Repair of Adršpach Gate

- Upper picture shows state of the sandstone gate (19.cetury)

main entry to the National Park of Adršpach Rocks. The upper cornice is inclined, the sandstone is hardly damaged in joints between the stones and also between the rock and stones.
- Lower picture shows detailed damage with pronounced erosion by the vegetation.

- Geopolymer matrix based on kaolinitic clay was filled by local sand and prepared a dense paste was applied between the sandstone blocks. The same material was used for fixing the lateral gate blocks to the massive rock.
- Geopolymer was chosen as a material non containing calcareous matters, which was excluded by the Union of natural conservators.
- The detailed view on geopolymer binder applied in between blocks of the gate.

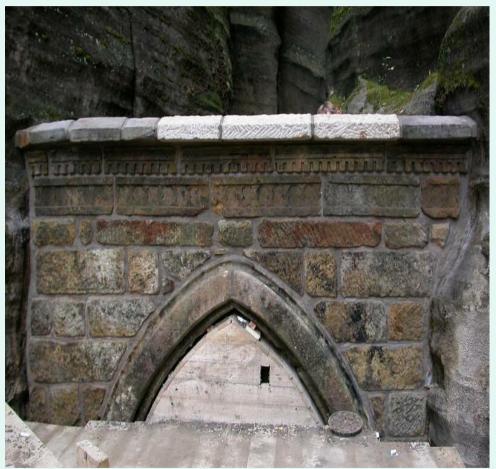
View on reconstructed gate

- New cornice stones were placed on the top substituting the most damaged ones. Well could be seen the joints between natural sandstone rocks and blocks of gate.
- The control after two years application constants perfect linkage on both sides and any destructions or damages even the gate is in shade and in wet surroundings.

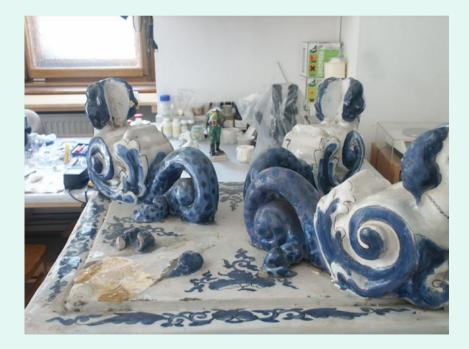
Top of pedestal with missing sphinx

<u>Delft Faïence</u>: step-like vase for flowers in shape of multilevel pagoda carried by four sphinxes

Creation of a copy: Geopolymer with porcelain dust
