Durability of Geopolymer Mortars (Fly Ash/Slag-Based) in Sulfate Environments

SUPPHATUCH UKRITNUKUN

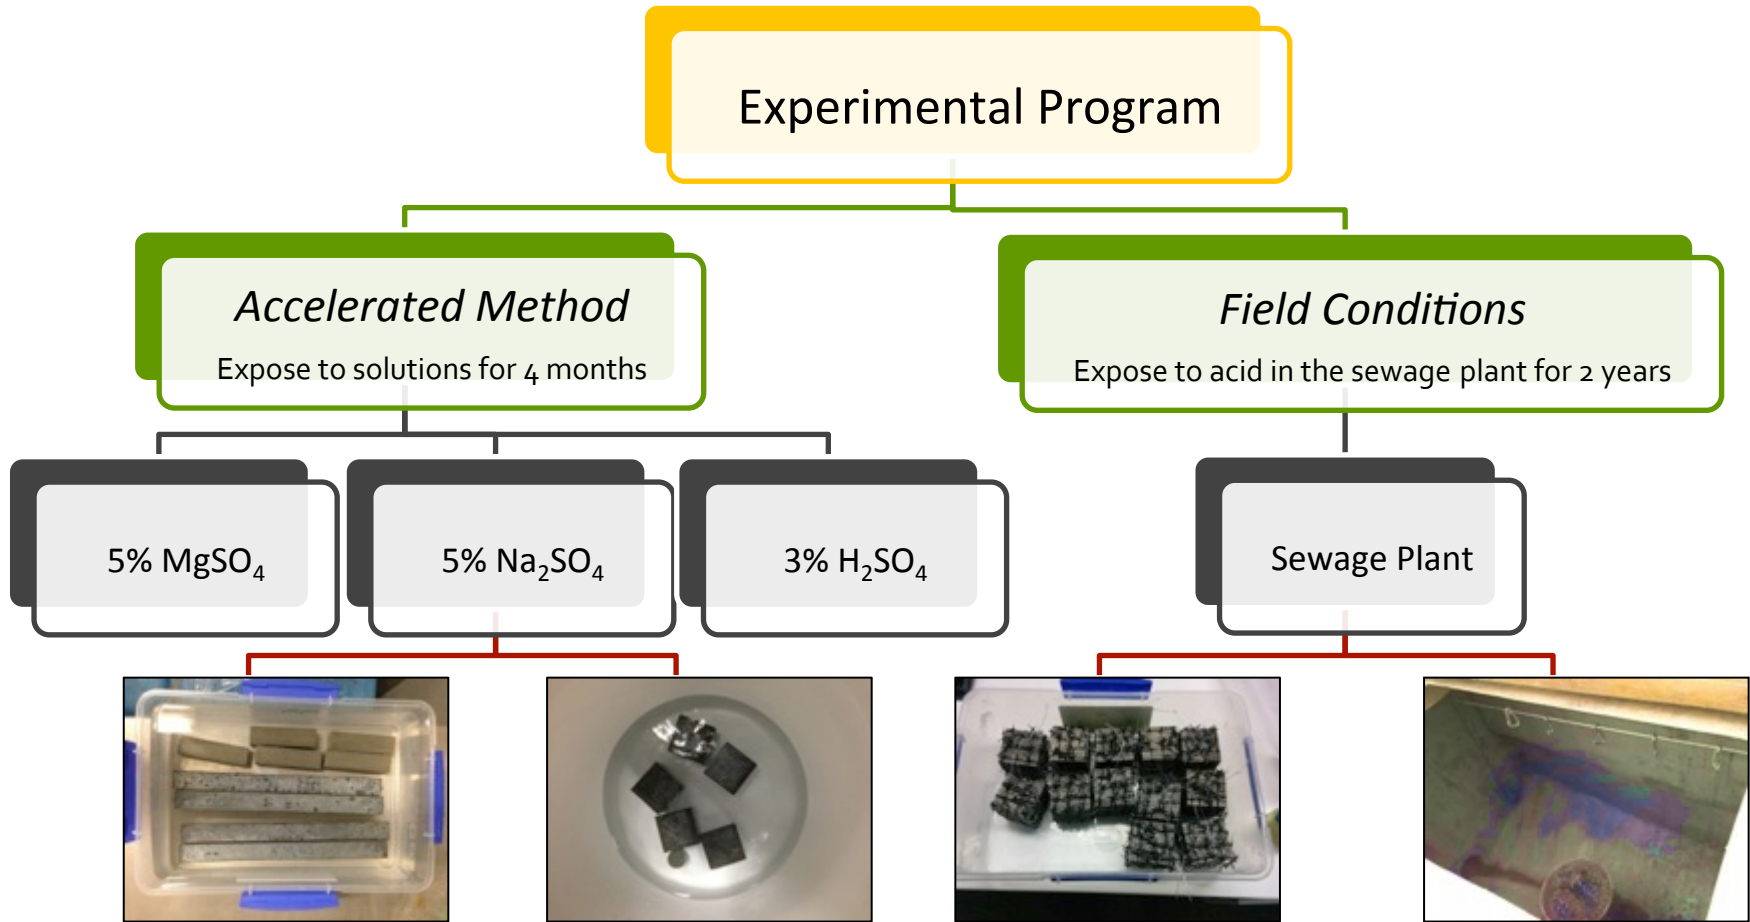
Experimental Program

Sulfate Solutions

- pH measurement
- Elemental Analysis (ICP)

Paste / Mortar

- Microstructural Analysis (SEM)
- Mineralogical Analysis (XRD)
- Compressive Strength Measurements
- Expansion Measurements

Accelerated Method in laboratory

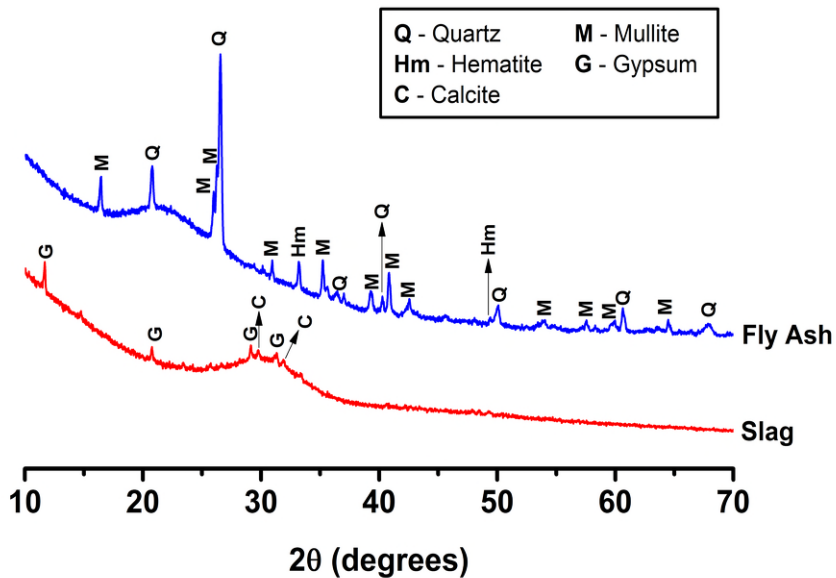
Raw Materials

Compound	Fly Ash (wt%)	Slag (wt%)
SiO ₂	66.1	33.6
Al ₂ O ₃	22.4	13.8
CaO	1.7	41.5
MgO	0.7	5.6
LOI	1.3	0.1

Compound	Grade D Sodium silicate (wt%)
SiO ₂	29.4
Na ₂ O	14.7
H ₂ O	55.9

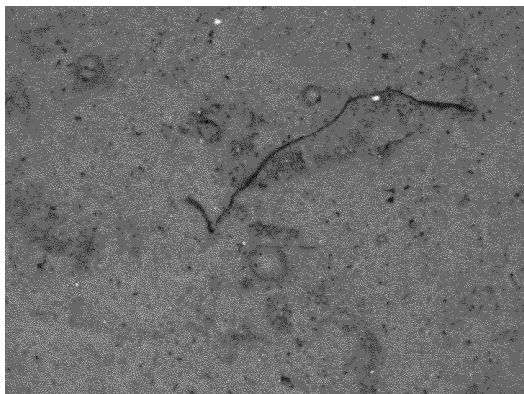
Microstructure

Before Exposure

MgSO₄ (4 weeks)

Na₂SO₄ (4 weeks)

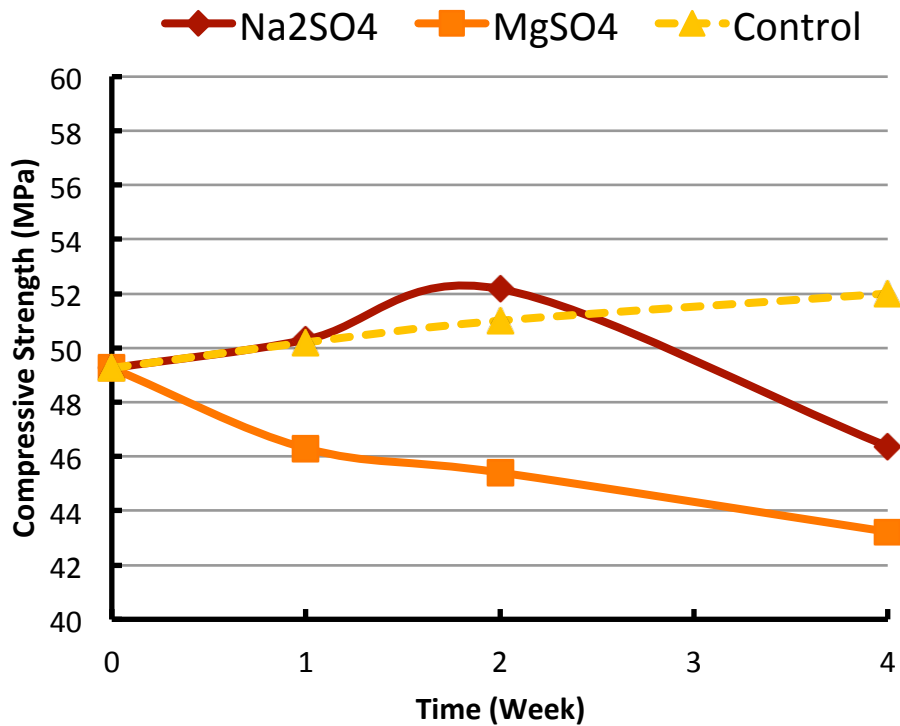
Compressive Strengths

- **Control:** Gradual increase in strength from 49 to 52 MPa over four weeks
- **Na₂SO₄:** In first two weeks, strength increases to ~ 52 MPa;
 - Na might be reacting to enhance geopolymerisation which compensates for leaching losses;
- After four weeks, strength falls to 46 MPa:
 - Geopolymerisation ceases; leaching continues causing cracking
- **MgSO₄:** Compressive strength declines from first week of exposure to 44 MPa
 - Decalcification from the matrix

- ◆ Presence of Mg decalcify the Ca-rich gel leads to the precipitation of gypsum
- ◆ MgSO_4 is more severe than Na_2SO_4 : reduction of compressive strength
- ◆ No visible cracks but the presence of micro cracks leads to the degradation of strength

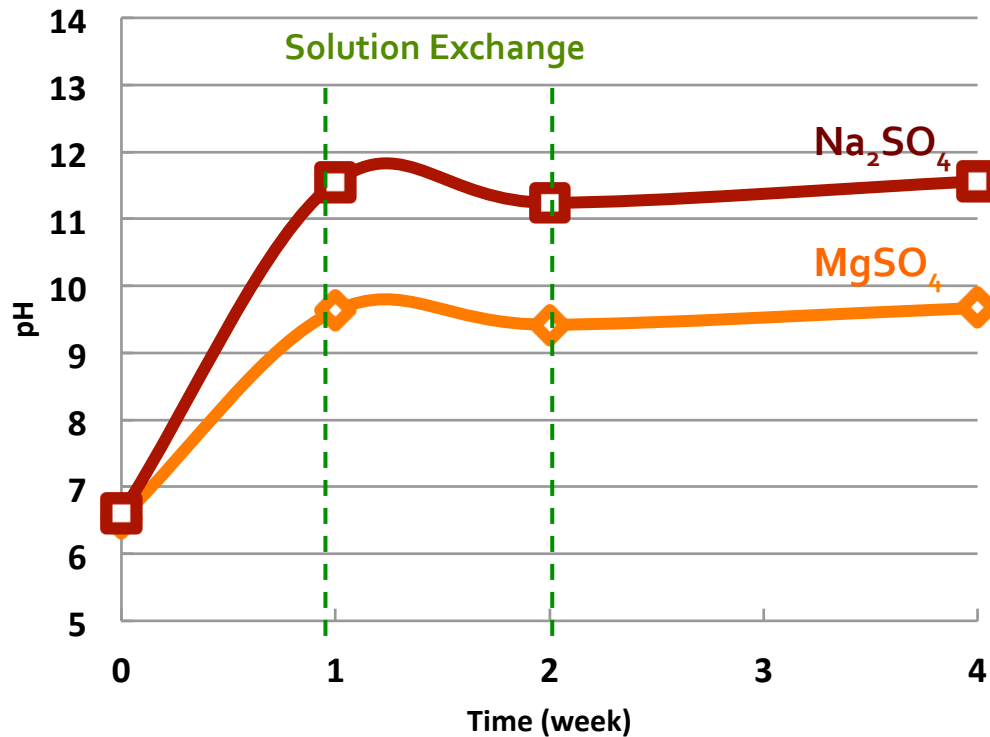
pH of the solutions

- Increased leaching of Si and Na in Na_2SO_4 results in rapid increase in pH
- Significant increase in pH in the first week in both test media
- After the solution exchange was done at the end of Week 1, there was a slight drop in pH
- After Week 4, the solution appears to have reached equilibrium and no further increase in pH was observed

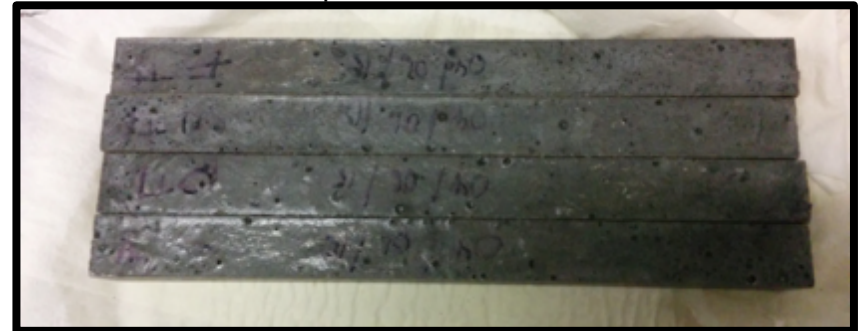
Expansion Measurement

5 wt% Na₂SO₄ (4 weeks)

5 wt% MgSO₄ (4 weeks)
