The geopolymer composition for restoration, construction and substitution

Hanzlicek Tomas, Perna Ivana, Steinerova Michaela

The Institute of Rock Structure and Mechanics of the Academy of Sciences in collaboration with Sculpture and restoration school of prof. P.Siegel City of Adršpach,

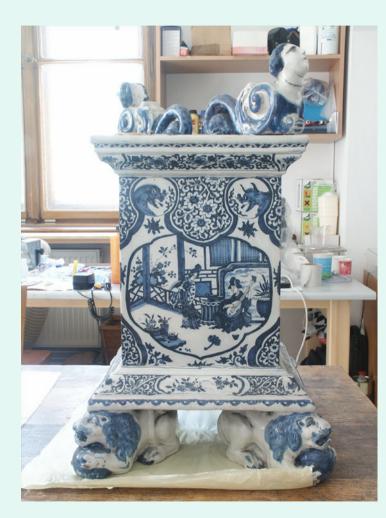
General view on pedestal

<u>Delft Faïence</u>: step-like vase for flowers in shape of multilevel pagoda carried by four sphinxes
