# Fire Resistance Properties of Waste Glass Incorporated Geopolymer Mortar

**GeoCamp 2018 – Saint Quentin**

Dr. Binyu ZHANG Prof. Chi-Sun POON Department of Civil and Environmental Engineering The Hong Kong Polytechnic University

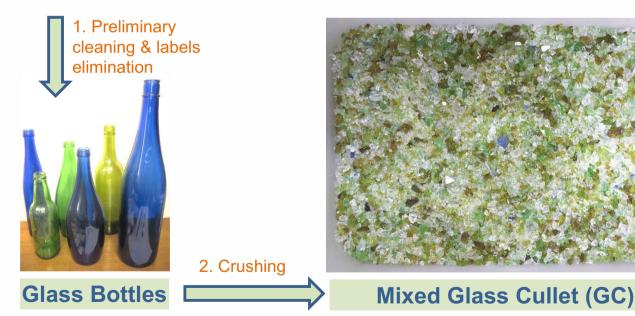
### **From Landfills to Raw Material**

Sieving

2.36-5mm

0.6-1.18mm

1.18-2.36mm

<0.6mm

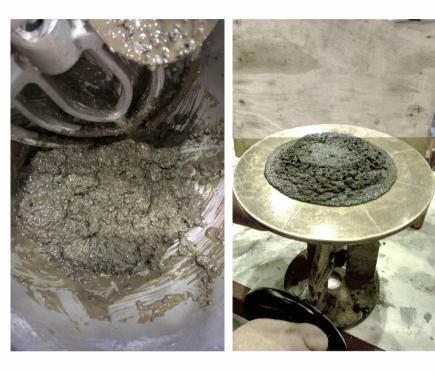
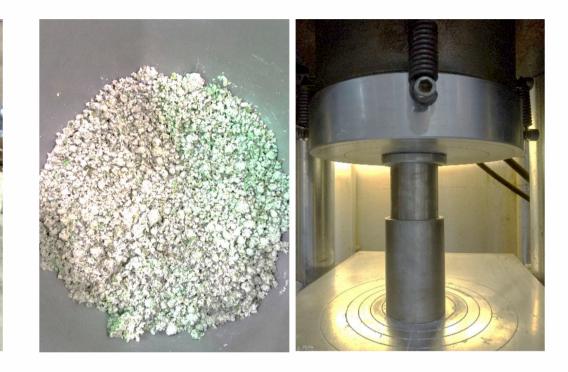
### **Two Mixing Schemes**

#### Wet mix scheme

### Dry mix scheme

- Flowable
- Casting under vibration

- Non-flowable
- Casting under compression (60kN)

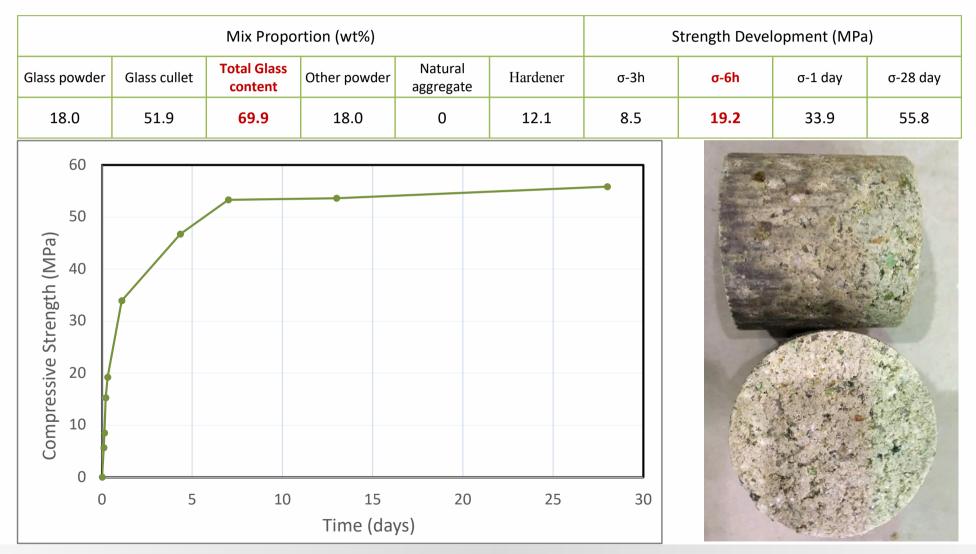
# **High Early Strength Development**

#### **Dry mix – Pre-cast Applications**

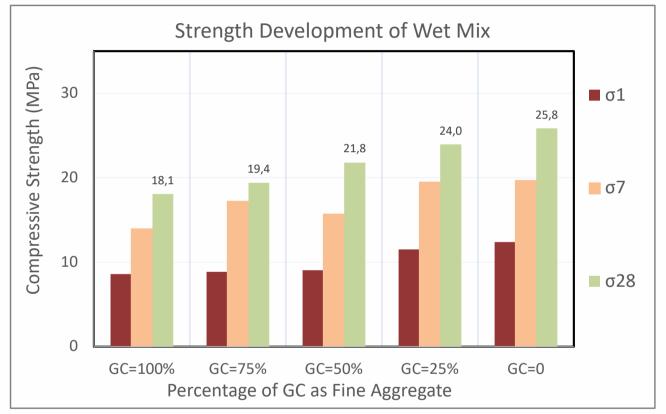
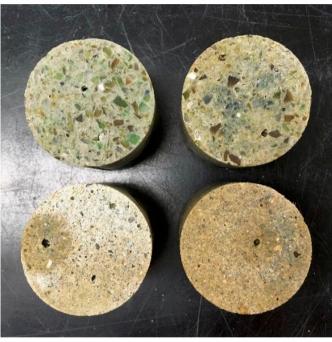
### **Strength Development**

### Wet Mix – Non-Structural Applications

- Cylindrical specimens D50mm\*H50mm casted for compressive strength test;
- Slightly strength loss occurred due to recycled glass cullet incorporation;
- Strength of mixture incorporating 100% GC was higher than 15MPa.

- Incorporation of glass cullet in geopolymer mortar led to reduced strength;
- High early strength development can be achieved via employing different mixing schemes;
- Incorporation of glass cullet resulted in significantly increased strength after fire test, though cracks and deformation appeared after exposure to high temperature;
- Coarser particles (2.36mm-5mm) glass cullet resulted in surface postfire cracks.

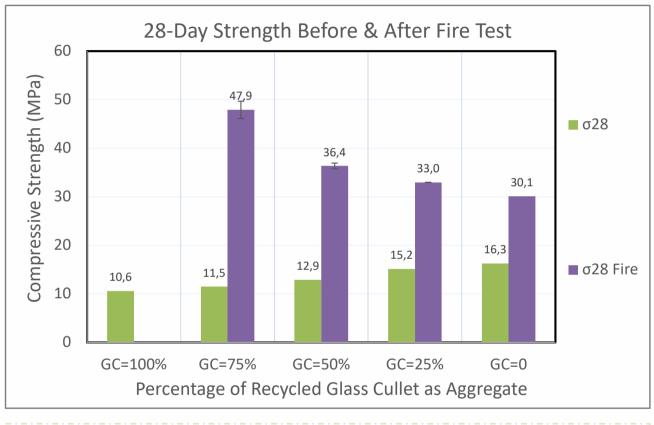
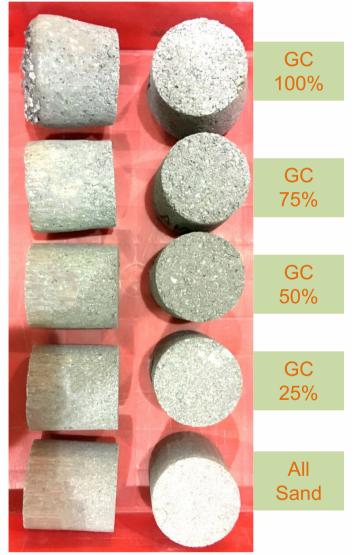
### **Issue 1-Deformation**

More obvious deformation occurred with increased proportion of recycled glass cullet in geopolymer

How to effectively avoid deformation, especially when glass cullet is added to mass construction elements?

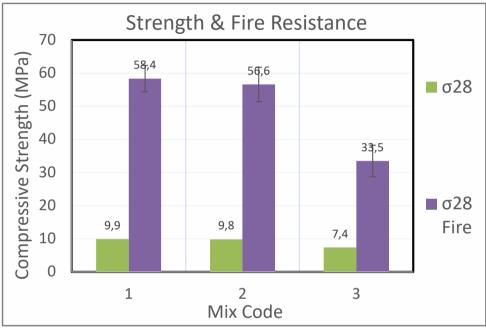
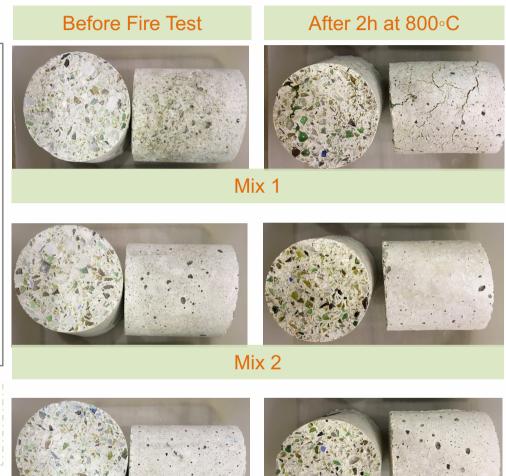
Mix 3

#### **Issue 2-Surface Cracks**

When all fine aggregates were recycled glass cullet, cracks appeared at some mixture proportions

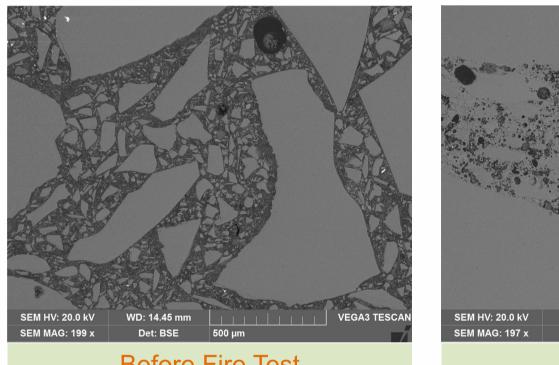
### **Back Scattered Electron Imaging**

#### Before Fire Test Glass cullet distributed in paste

After Fire Test Glass particles melted together

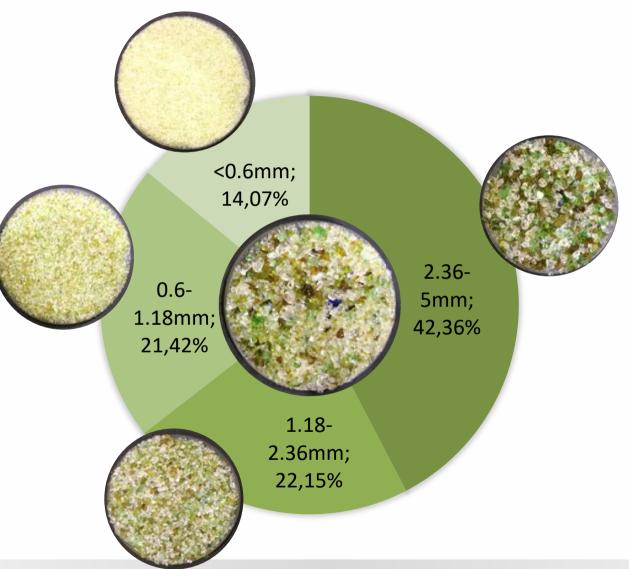
### **Glass Cullet Sieving**

How to avoid cracks without high labour cost pre-treatment of recycled glass materials? (e.g., sieving)

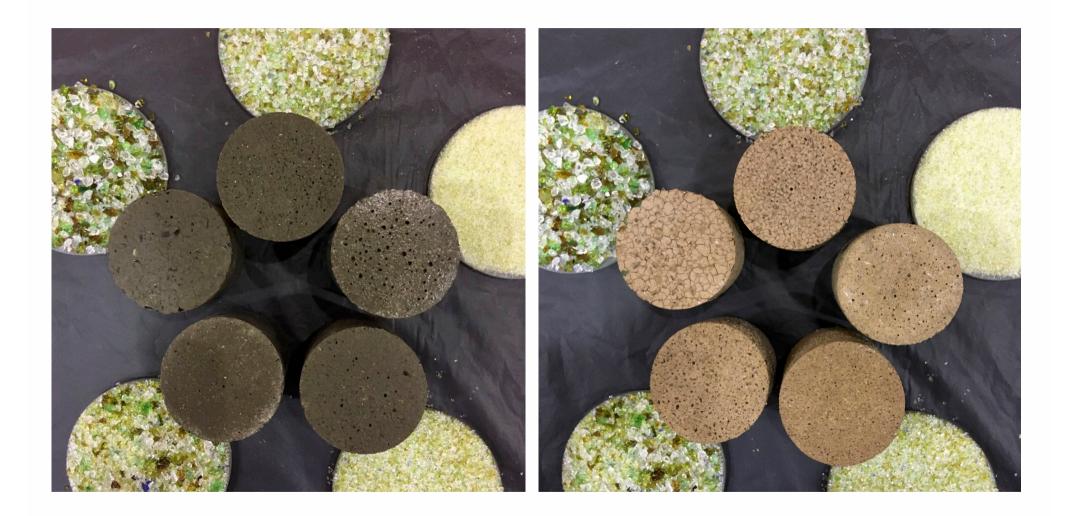
### Before & After 800°C
